# **NATIONAL TRANSPORTATION SAFETY BOARD**

## **HAZARDOUS MATERIALS SPECIAL INVESTIGATION REPORT**

**HAZARDOUS MATERIALS RELEASE  
MISSOURI PACIFIC RAILROAD COMPANY'S  
NORTH LITTLE ROCK, ARKANSAS  
RAILROAD YARD  
DECEMBER 31, 1984**

NTSB/SIR-85/03

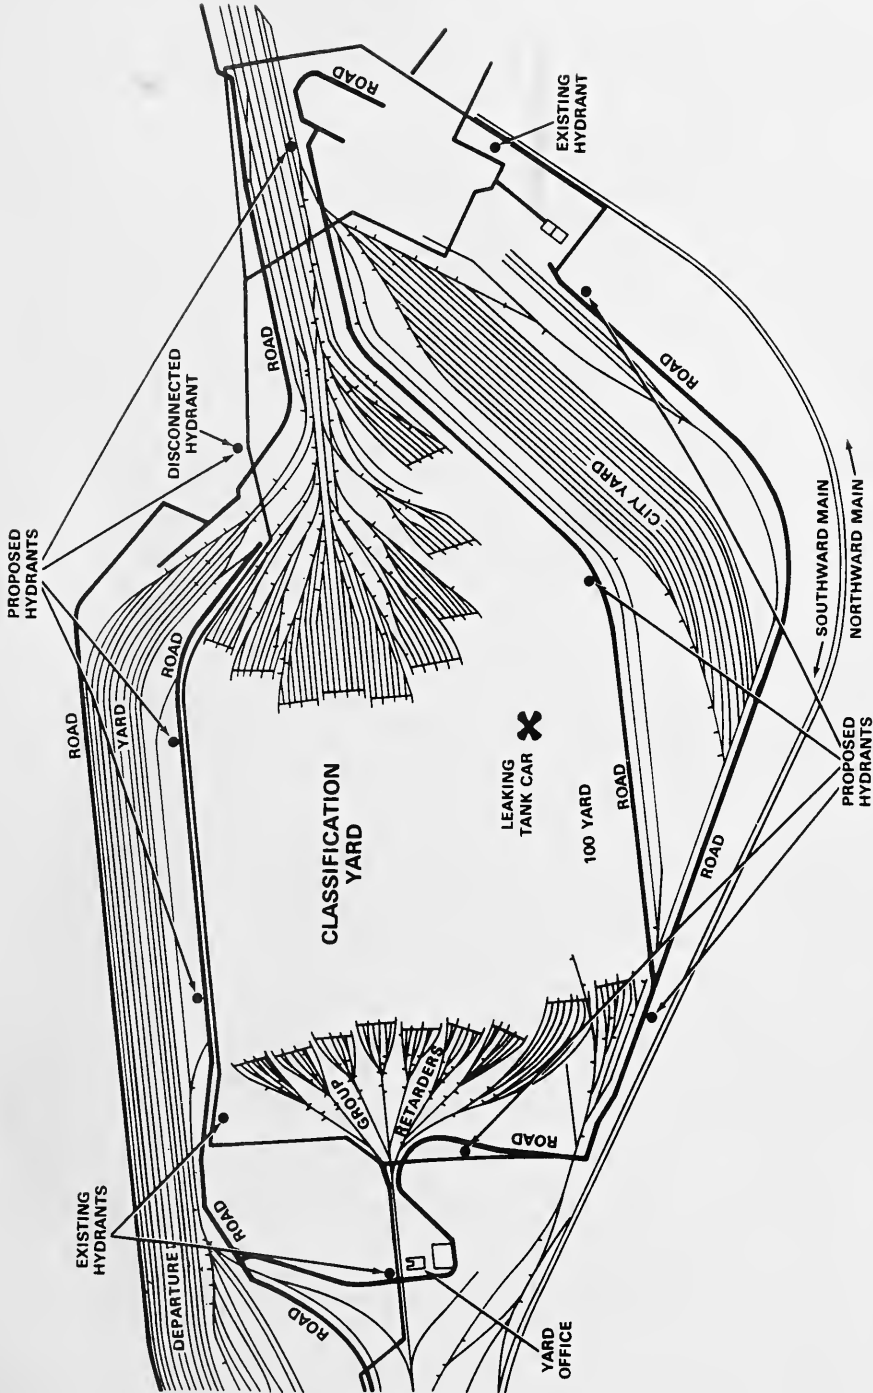
Fire department personnel tested three fire hydrants in the yard. The first hydrant tested had no water (it had been disconnected earlier from the water main because of construction). The second hydrant had less than 1 pound of water flow pressure, and the third hydrant, which was an estimated 1,875 feet from the leaking ethylene oxide tank car, had less than 10 pounds of water flow pressure. The fire chief stated that the low water pressure was insufficient to supply water through firehoses. To lay firehose to the leaking tank car from any of the fire hydrants, it would have been necessary for the firehose to cross many railroad tracks, some of which were occupied by freight cars. The nearest road was about 437 feet from the leaking tank car, and 21 railroad tracks were between the road and the leaking tank car, with most of the tracks occupied with freight cars. (See figure 2.)

Figure 2.—Sketch of railroad yard showing tracks, fire water system, and access roads in relation to the leaking tank car.

Roads within the yard are located parallel to the northern-most classification track, and the southern-most track in the One Hundred Yard. A 4-inch steel fire water main with a fire hydrant is located across from the northern most classification track about 1,550 feet from the location of the leaking tank car. A fire hydrant is located

10. Missouri Pacific Railroad Company's North Little Rock, Arkansas, railroad yard fire main system was inadequately designed and maintained.

demand; and the availability of hydrants near areas where emergency conditions can be anticipated, especially in the classification yard where the distance between fire hydrants would require laying the fire hose across up to 36 railroad tracks. Before these improvements are undertaken, a detailed analysis should be conducted in consultation with the fire department of the fire main needs based on potential emergencies which may occur in the yard.

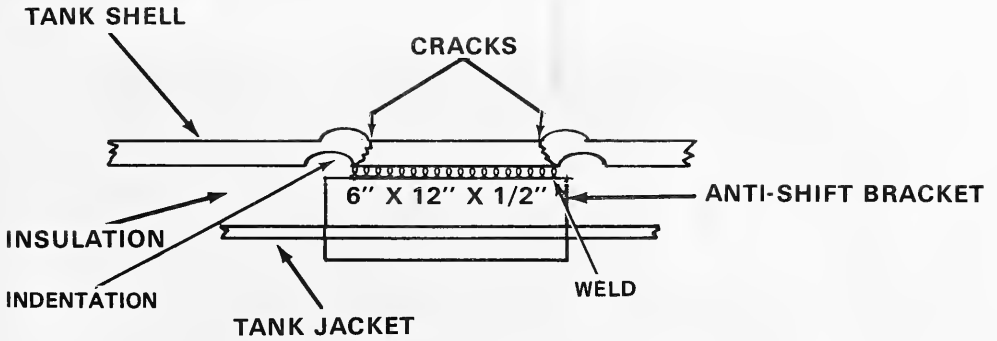
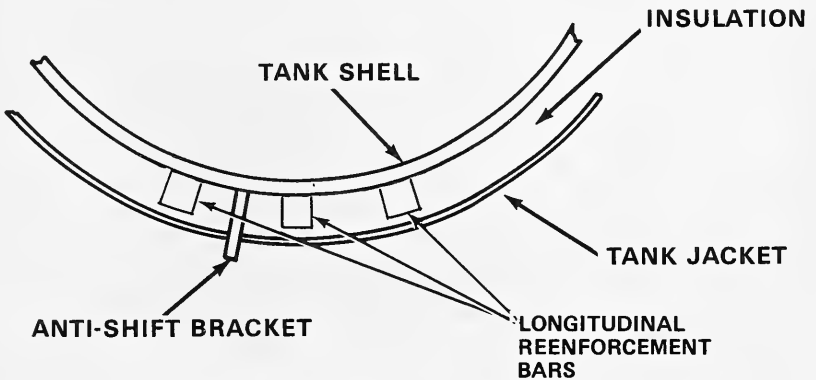
Figure 3.--Sketch of tank car sample area.

Metallurgists from Carbide and the Safety Board removed a section of the tank shell for metallurgical examination. The section included two through-shell cracks, two indentations, a section of the tank shell bottom plate longitudinal reinforcing bar, the anti-shift bracket, and part of the jacket that was attached to the anti-shift bracket. (See figures 3 and 4.) The metallurgical examination was conducted by a metallurgical consultant in Houston, Texas, under the supervision of the Safety Board's metallurgist.

Microscope examination of the opened through shell cracks showed a "woody" fracture face. The origins were shown to be at the under cut at the toe of the weld nugget (shell side) on each side at each end of the vertical fin. The weld nugget was much larger on one side. Both sides of both ends of the weld nuggets contained "old" fractures. Also, the final fracture phase of each crack was mechanically damaged.

Scanning electron microscopic examination of the fracture faces that were opened for examination revealed a ductile tensile overload mode for both the "A" and "B" samples. The "woody" morphology was very evident for both samples. It was also evident that the initial fracture was much older than the final through wall fracture area. The initial cracks were all initiated in the undercuts that were located at each nugget toe on the shell side. Some final fracture areas showed evidence of mechanical damage. The old fracture areas were easy to identify by the degree of corrosion that was present with respect to the recent fractures.

- (1) The progression of the cracks at the toe of the fillet weld to shell indicates that the cause is plastic-hinge (repeated) tensile stress. The progression is in an inward shell thickness direction, that is not preferential to Heat Affected Zone (HAZ), except at the geometric induced starting point. The opening up of inclusion sites on both sides of the cracks clearly indicates tensile crack-opening stress due to hinge point rotation of repeated type.

- (4) The penetration of the shell at the two ends of the fillet welds to shell connection is due to a progression of low cycle fatigue crack from A and B ends of the vertical bracket. The sites that developed the first cracking were the sites of first complete penetration. The low cycle fatigue cracking mechanism is consistent with the type of final penetration of shell.

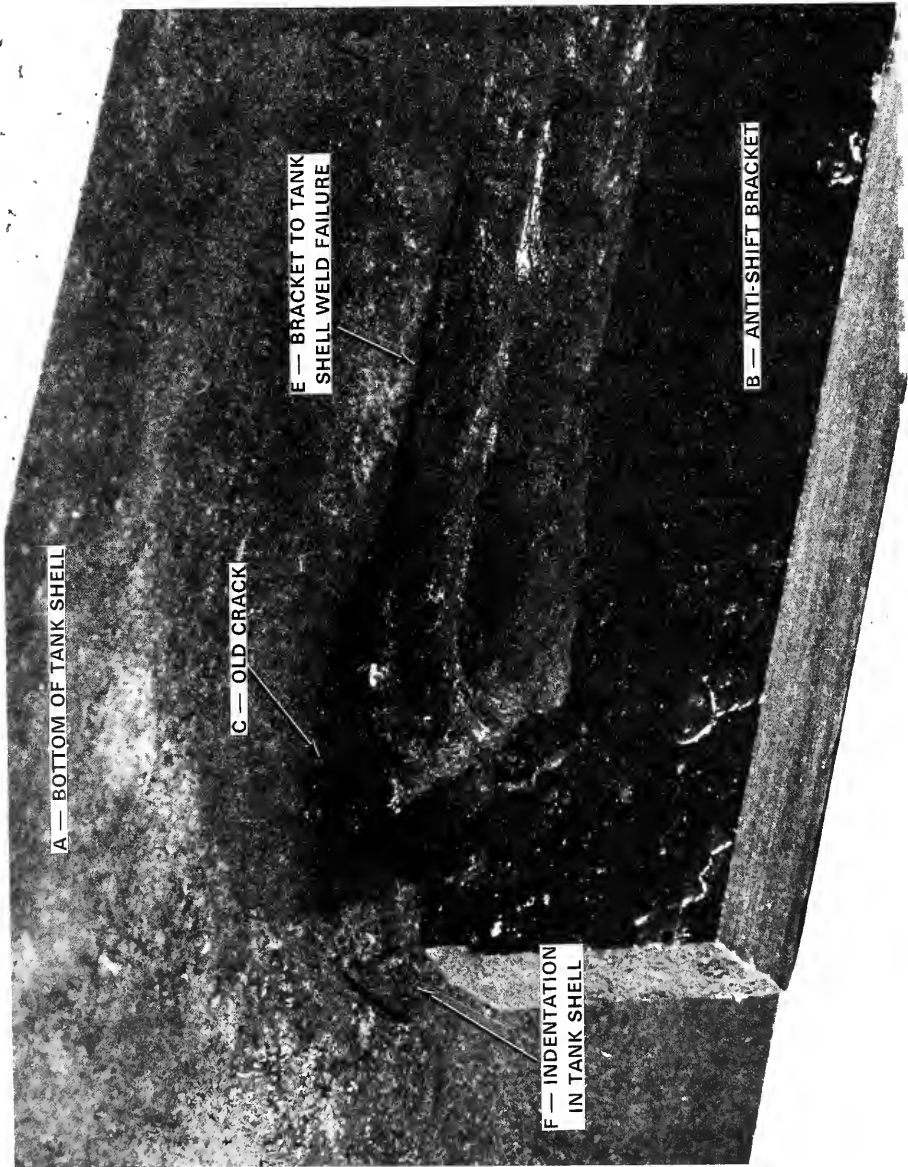
Figure 4.—Photograph of anti-shift bracket.

All parties to the Safety Board's investigation agreed that the anti-shift bracket was not installed in accordance with Federal requirements and that cracks existed in the tank shell that predated the release; however, there was disagreement as to the cause of the final failure of the tank shell. One view is that the failure was caused by a single event, such as an overspeed coupling; however, the fact that other tank cars had cracks of varying depths which had not yet propagated through the tank shell discounts the single event theory. The Safety Board believes that it is more likely that the failure developed over a period of time in routine railroad operations, which may have included overspeed couplings, resulting in progressive cracking. Because of the way the anti-shift brackets were installed, tank car RAIIX 7033 and others so designed were prone to failure as a result of forces in normal operations dependent primarily upon the type and extent of service for which they were used.

In this accident, ethylene oxide was released through the through-shell cracks caused by the improper attachment of the anti-shift bracket directly to the tank shell. Additional quantities of ethylene oxide were released to the environment during Carbide's unsuccessful attempts to transfer the volatile liquid from the leaking tank while using a makeshift piping system. The later actions increased the hazard to the public and emergency response personnel during the emergency.

Evaluate for adequacy and timeliness, directing changes as necessary, the General American Transportation Corporation's proposed inspection and repair program for bringing tank cars on which anti-shift brackets are welded directly to the tank shell into regulatory compliance, and monitor the completion of the program. (R-85-60)
